FEDERAL AVIATION ADMINISTRATION
AIRWORTHINESS DIRECTIVES
SMALL AIRCRAFT, ROTORCRAFT, GLIDERS,
BALLOONS, & AIRSHIPS

BIWEEKLY 2000-09

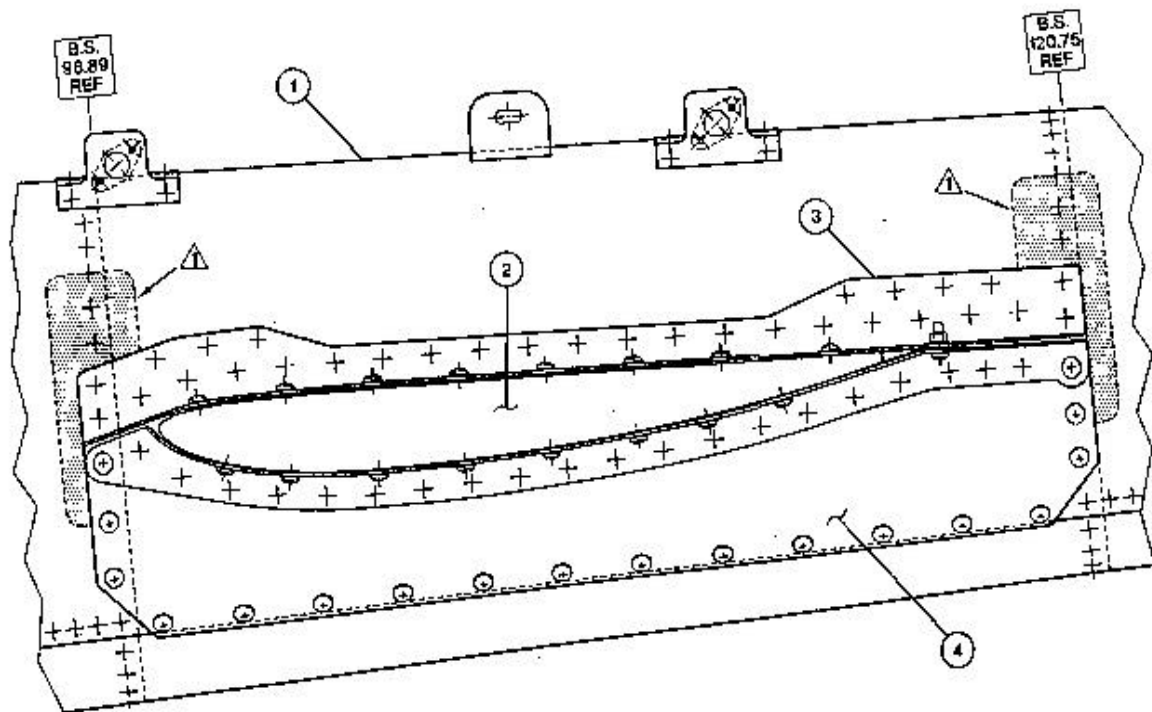
Figure 1. Preflight Check of the Tailboom

(a) Before further flight and thereafter before the first flight of each day, check the left side of the tail boom for a crack in the areas shown in Figure 1. If a crack is found, replace the tail boom with an airworthy tail boom before further flight.

- ⚠ Examine these areas for cracks on left side of tailboom only.
2. Horizontal stabilizer not shown for clarity.

(c) Within 25 hours time-in-service (TIS) and thereafter at intervals not to exceed 50 hours TIS, visually inspect any tail boom with 600 or more hours TIS for a crack using a 10X or higher magnifying glass, in accordance with the Accomplishment Instructions, Part II, of Bell Helicopter Textron Canada Alert Service Bulletin 407-99-26, dated April 13, 1999, except that you are not required to contact Bell Helicopter Product Support Engineering. If a crack is found, replace the tail boom with an airworthy tail boom before further flight.

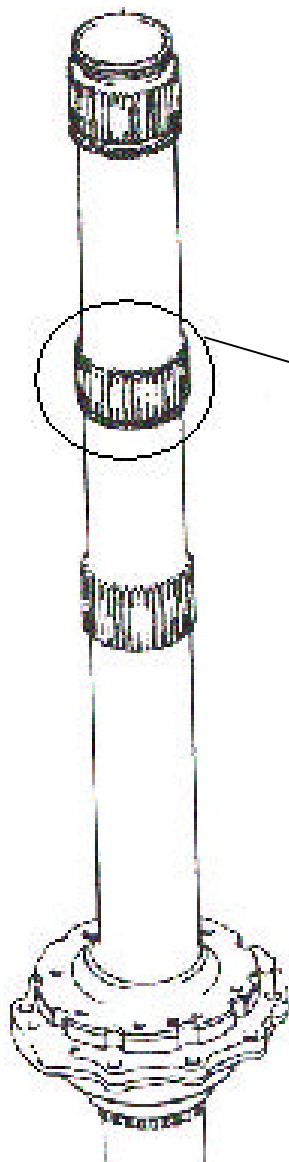
Figure 1

Inspect area for:

- At 100x minimum magnification
Minimum radius of 0.020 at the
snap ring groove/spline intersection
- At 200x minimum magnification
Burrs in the snap ring groove

(4) If any snap ring groove radius is less than 0.020 inches, replace the mast with an airworthy mast before accumulating 100,000 RIN or before further flight if RIN exceeds 100,000.

(6) If a burr is found in any snap ring groove radius, replace the mast with an airworthy mast before accumulating 170,000 RIN or before further flight if RIN exceeds 170,000.

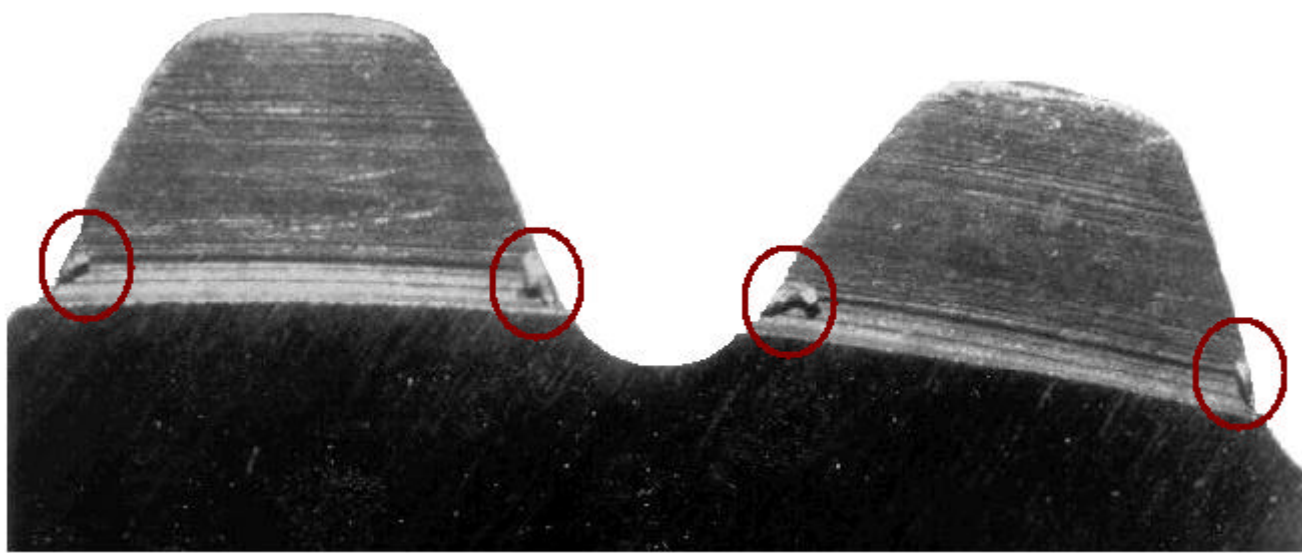
Figure 3
Typical Burr at Snap Ring Groove

Cutaway View Looking Down from Inside Snap Ring Groove
Typical Burrs at Snap Ring Groove/Spline Intersection
Burrs are to be Inspected at 200x Minimum Magnification

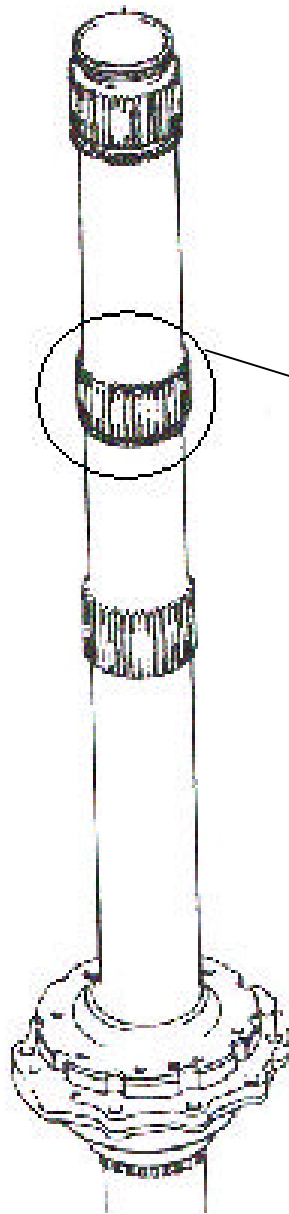
Figure 3
Main Rotor Mast

Inspect area for:

- At 100x minimum magnification
Minimum radius of 0.020 at the
snap ring groove/spline intersection
- At 200x minimum magnification
Burr in the snap ring groove

(7) If any snap ring groove radius is less than 0.020 inches, replace the mast with an airworthy mast before accumulating 100,000 RIN or before further flight if the RIN equals or exceeds 100,000.

(9) If a burr is found in any snap ring groove radius, replace the mast with an airworthy mast before accumulating 170,000 RIN or before further flight if the RIN equals or exceeds 170,000.

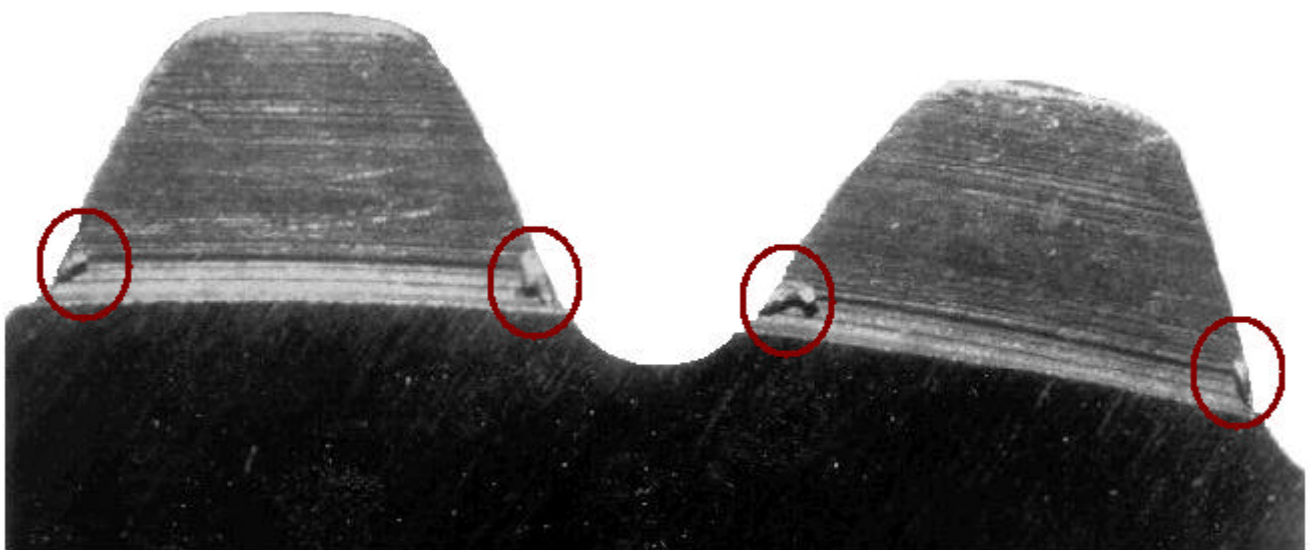
Cutaway View Looking Down From Inside Snap Ring Groove

Typical Burrs at Snap Ring Groove / Spline Intersection
